M3 Seat Leather Restoration

Restoring the Vader seats on an E36 M3

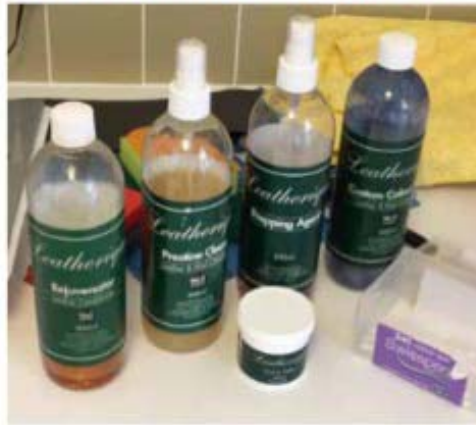
Since getting the car back, I have spent a lot of time & money bringing it back to its original glory. After major detailing, paint correction and part replacements, the only issue I had with the car was the driver's seat leather.

It's a 4-step process; Rejuvenate, Cleanse, Sand & Fill, and Colour.

I first gave the interior a very careful clean and wiped all the leather down with a damp cloth.

I then applied a generous covering of Rejuvenator Oil, massaging it in with my hands. I let it soak in for 24 hours and repeated the process 4 times over about a week. Next, I used the Pristine Clean solution to clean up the residue, followed by a wipe with a damp cloth.

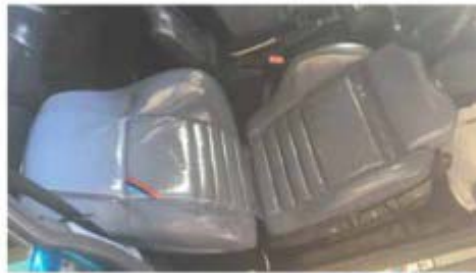
After allowing the seats to dry, the scary part began. This involved sanding the damaged area with wet & dry

sandpaper to remove the damaged surface.

After that, I mixed some of the dye with the white filler and filled the cracks, allowed it to dry then sanded it all flat.

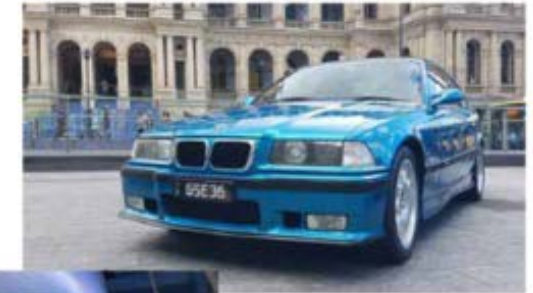
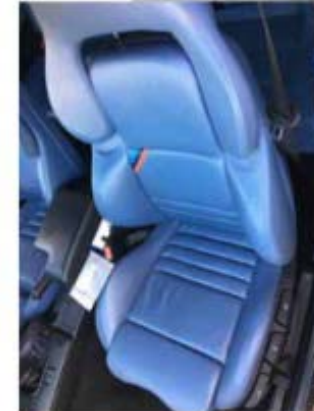
The final step was the dyeing of the seats. I taped off the areas where I was not restoring the leather first, then mixed the dye constantly (it separates quickly). I then added some dye into a bowl after mixing it in the bottle and used a slightly damp microfiber pad to very lightly dab numerous coats of dye, waiting an hour or more between applications. I resisted the urge to apply thicker coats to cover the filler, but it did eventually disappear with multiple thin coats.

I was very proud to win best in my class at the 2017 BMW Club Nationals Show & Shine, but if I must be honest, the seat has started to crack again on my repairs after some use, so sadly, it's not perfect.
